Memorandum

To: Mark Raney, Volpe Center Task Order Manager

From: Nick Raines, CDM Field Team Leader

Subject: Flower Creek Investigation Summary

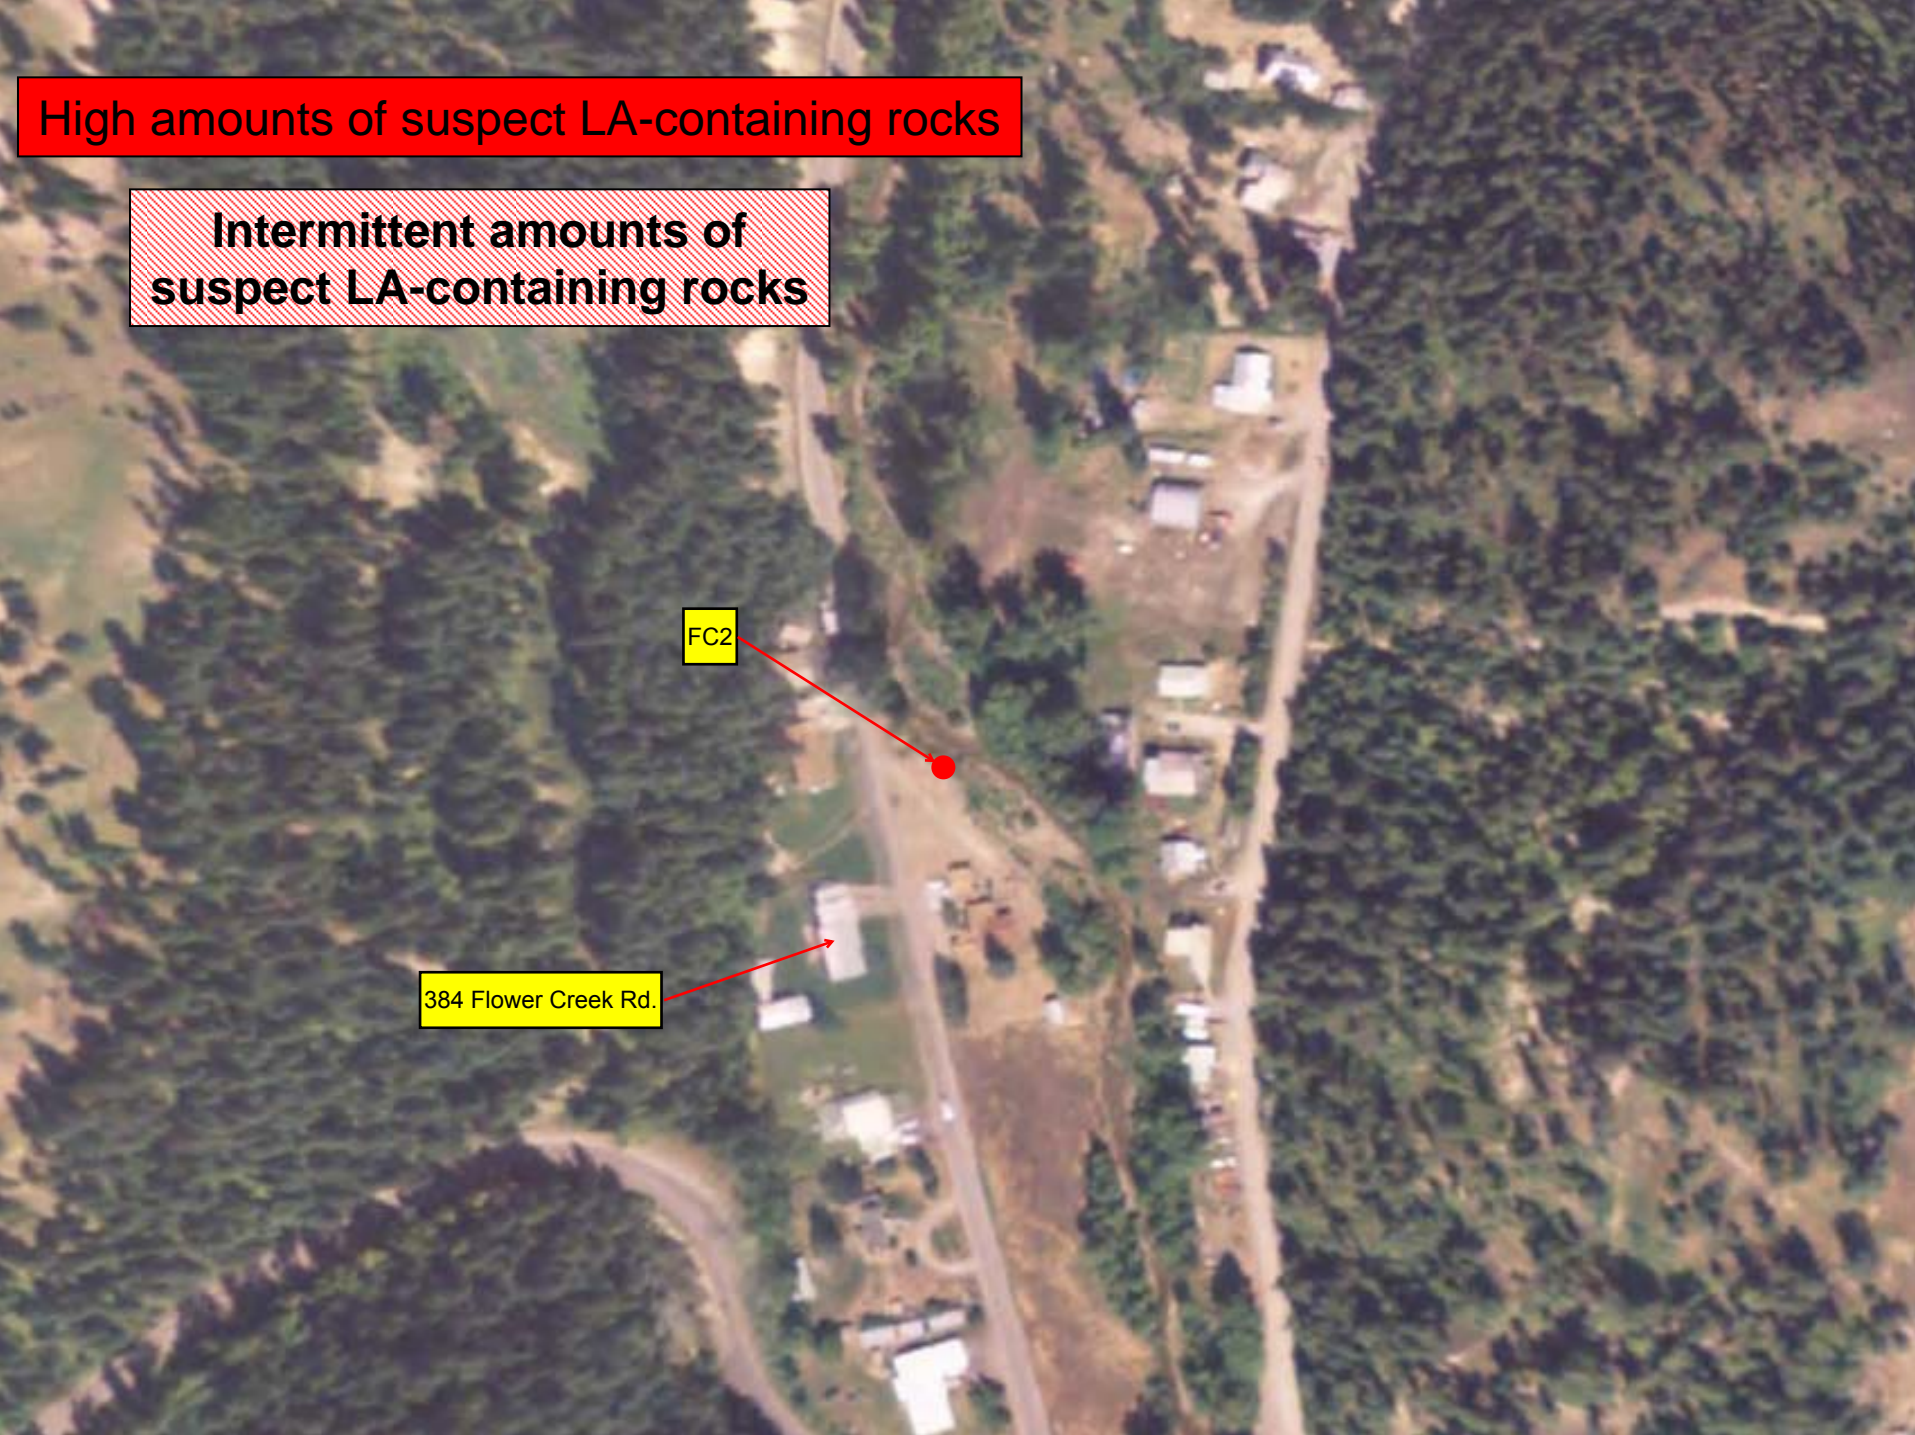
FC2

384 Flower Creek Rd.

High amounts of suspect LA-containing rocks

Intermittent amounts of
suspect LA-containing rocks

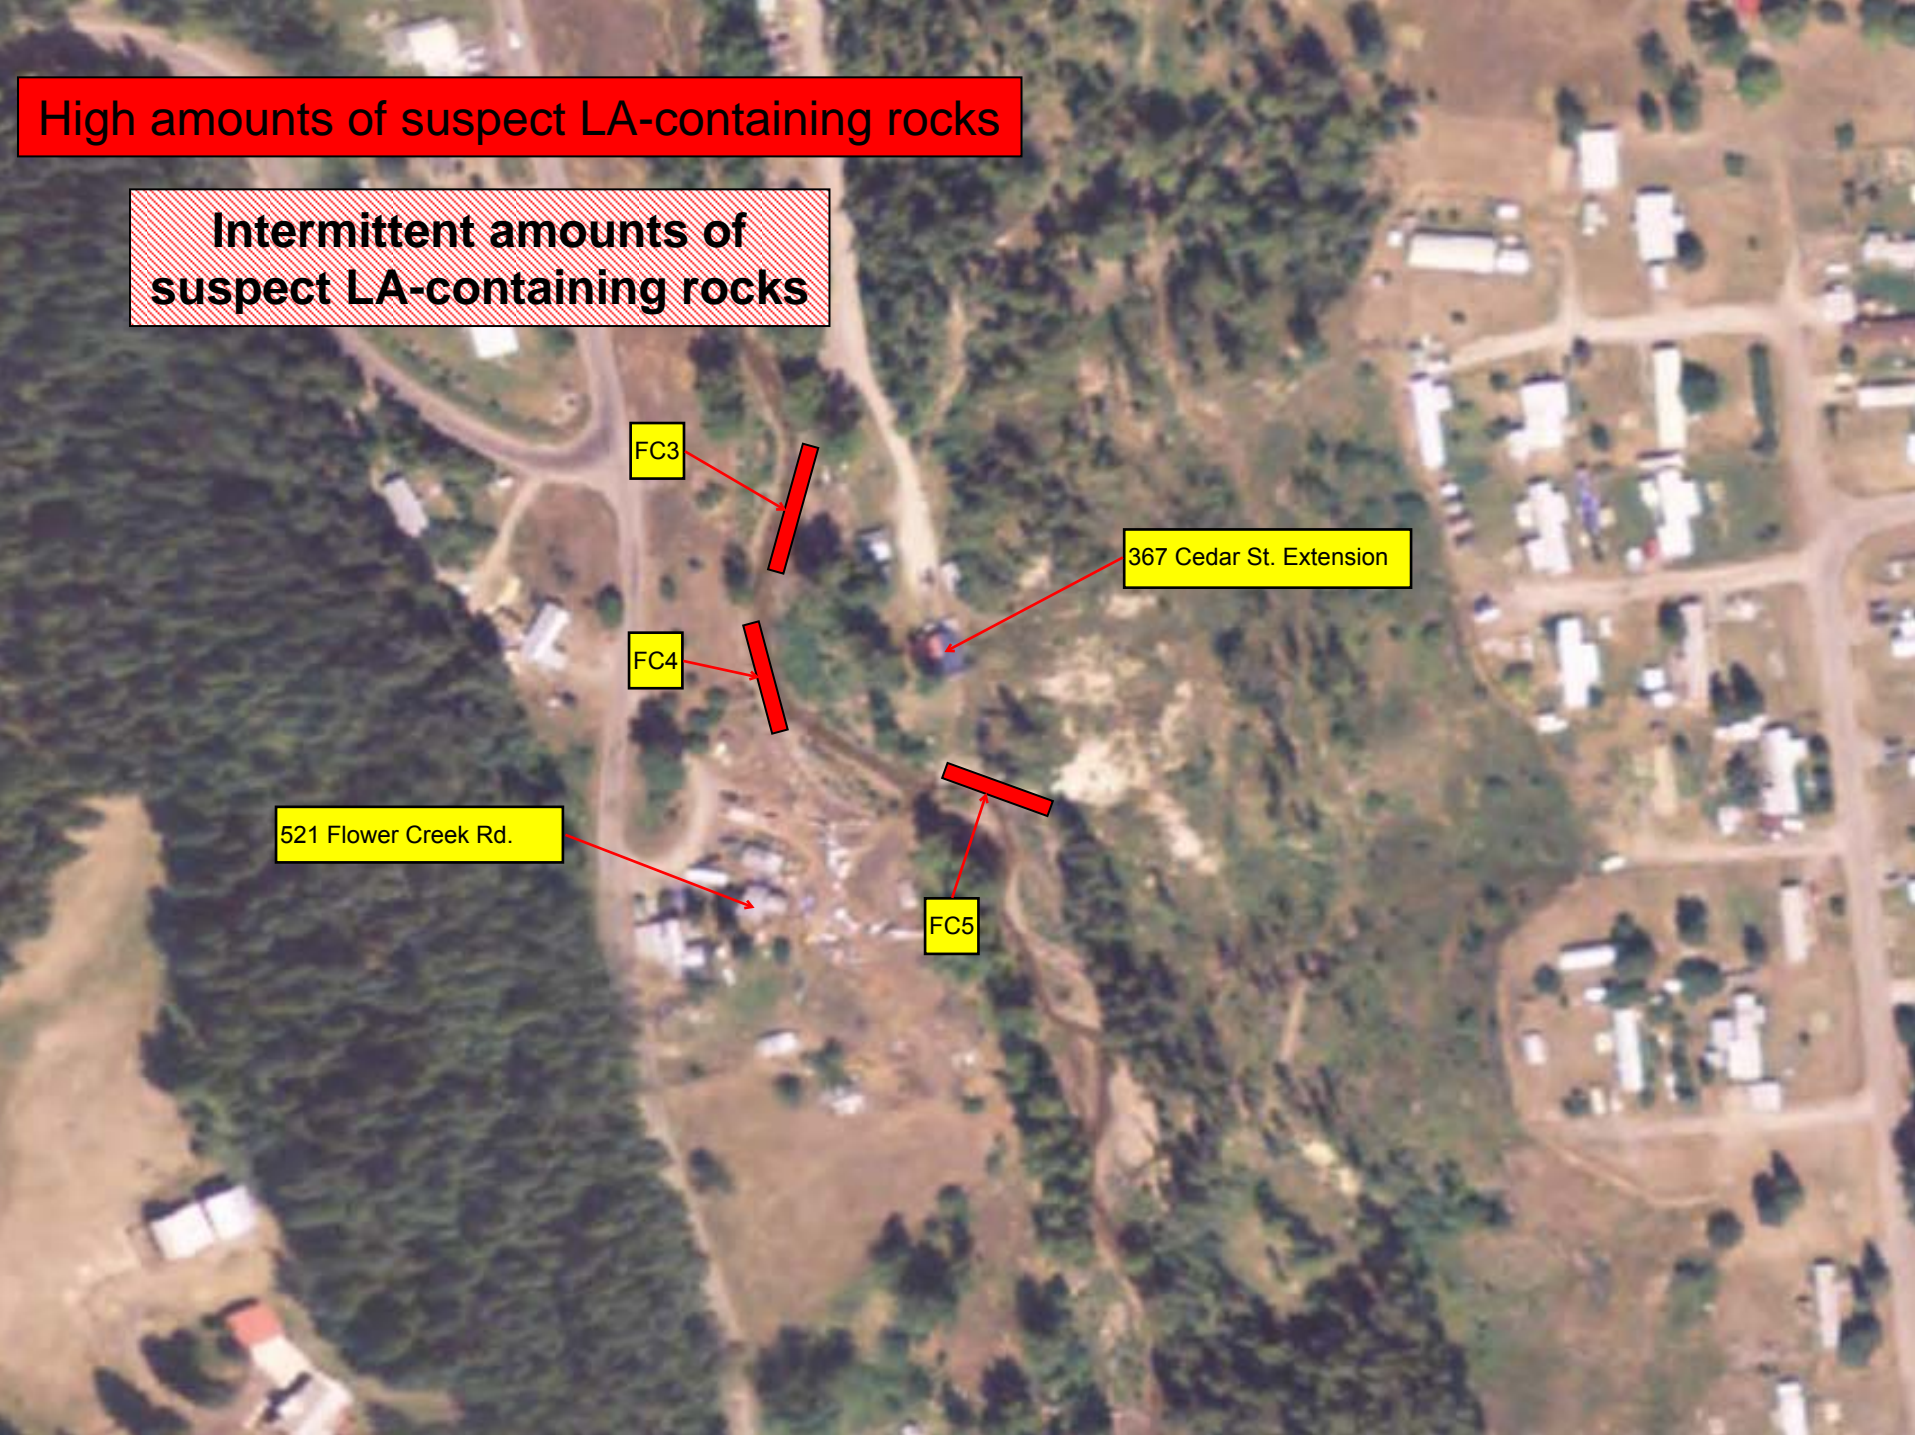
FC3

Located along the east creek bank adjacent to 367 Cedar St Ext, this location contains a large deposit of suspect materials with rocks that are approximately 24 inches in diameter. Small pieces of amphibole and vermiculite were also readily observed at this location.

367 Cedar St. Extension

High amounts of suspect LA-containing rocks

Intermittent amounts of
suspect LA-containing rocks

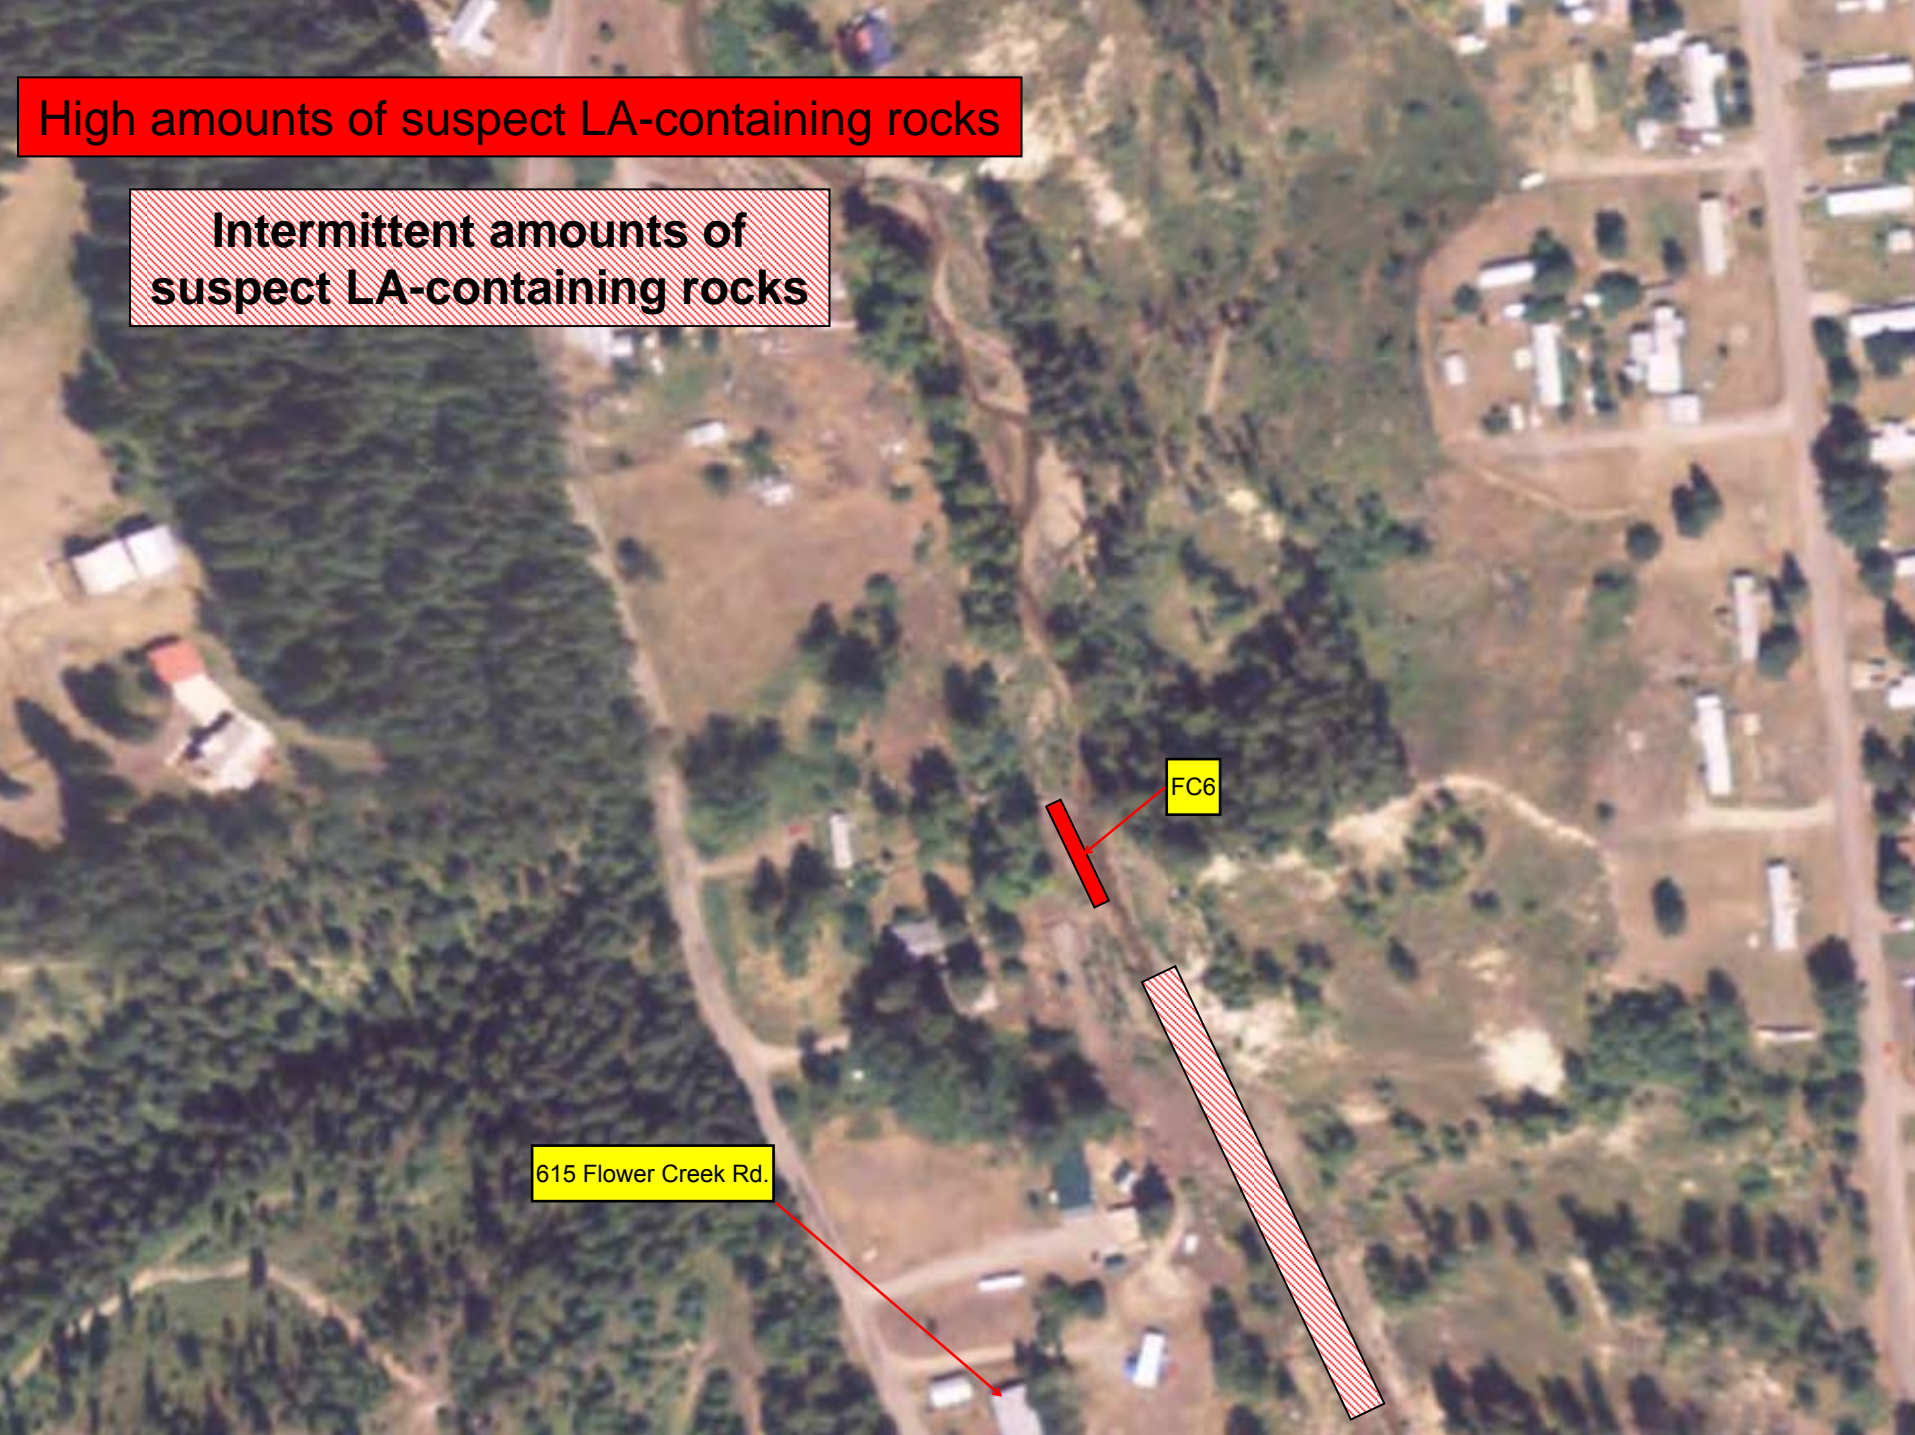
FC6

615 Flower Creek Rd.

High amounts of suspect LA-containing rocks

Intermittent amounts of suspect LA-containing rocks

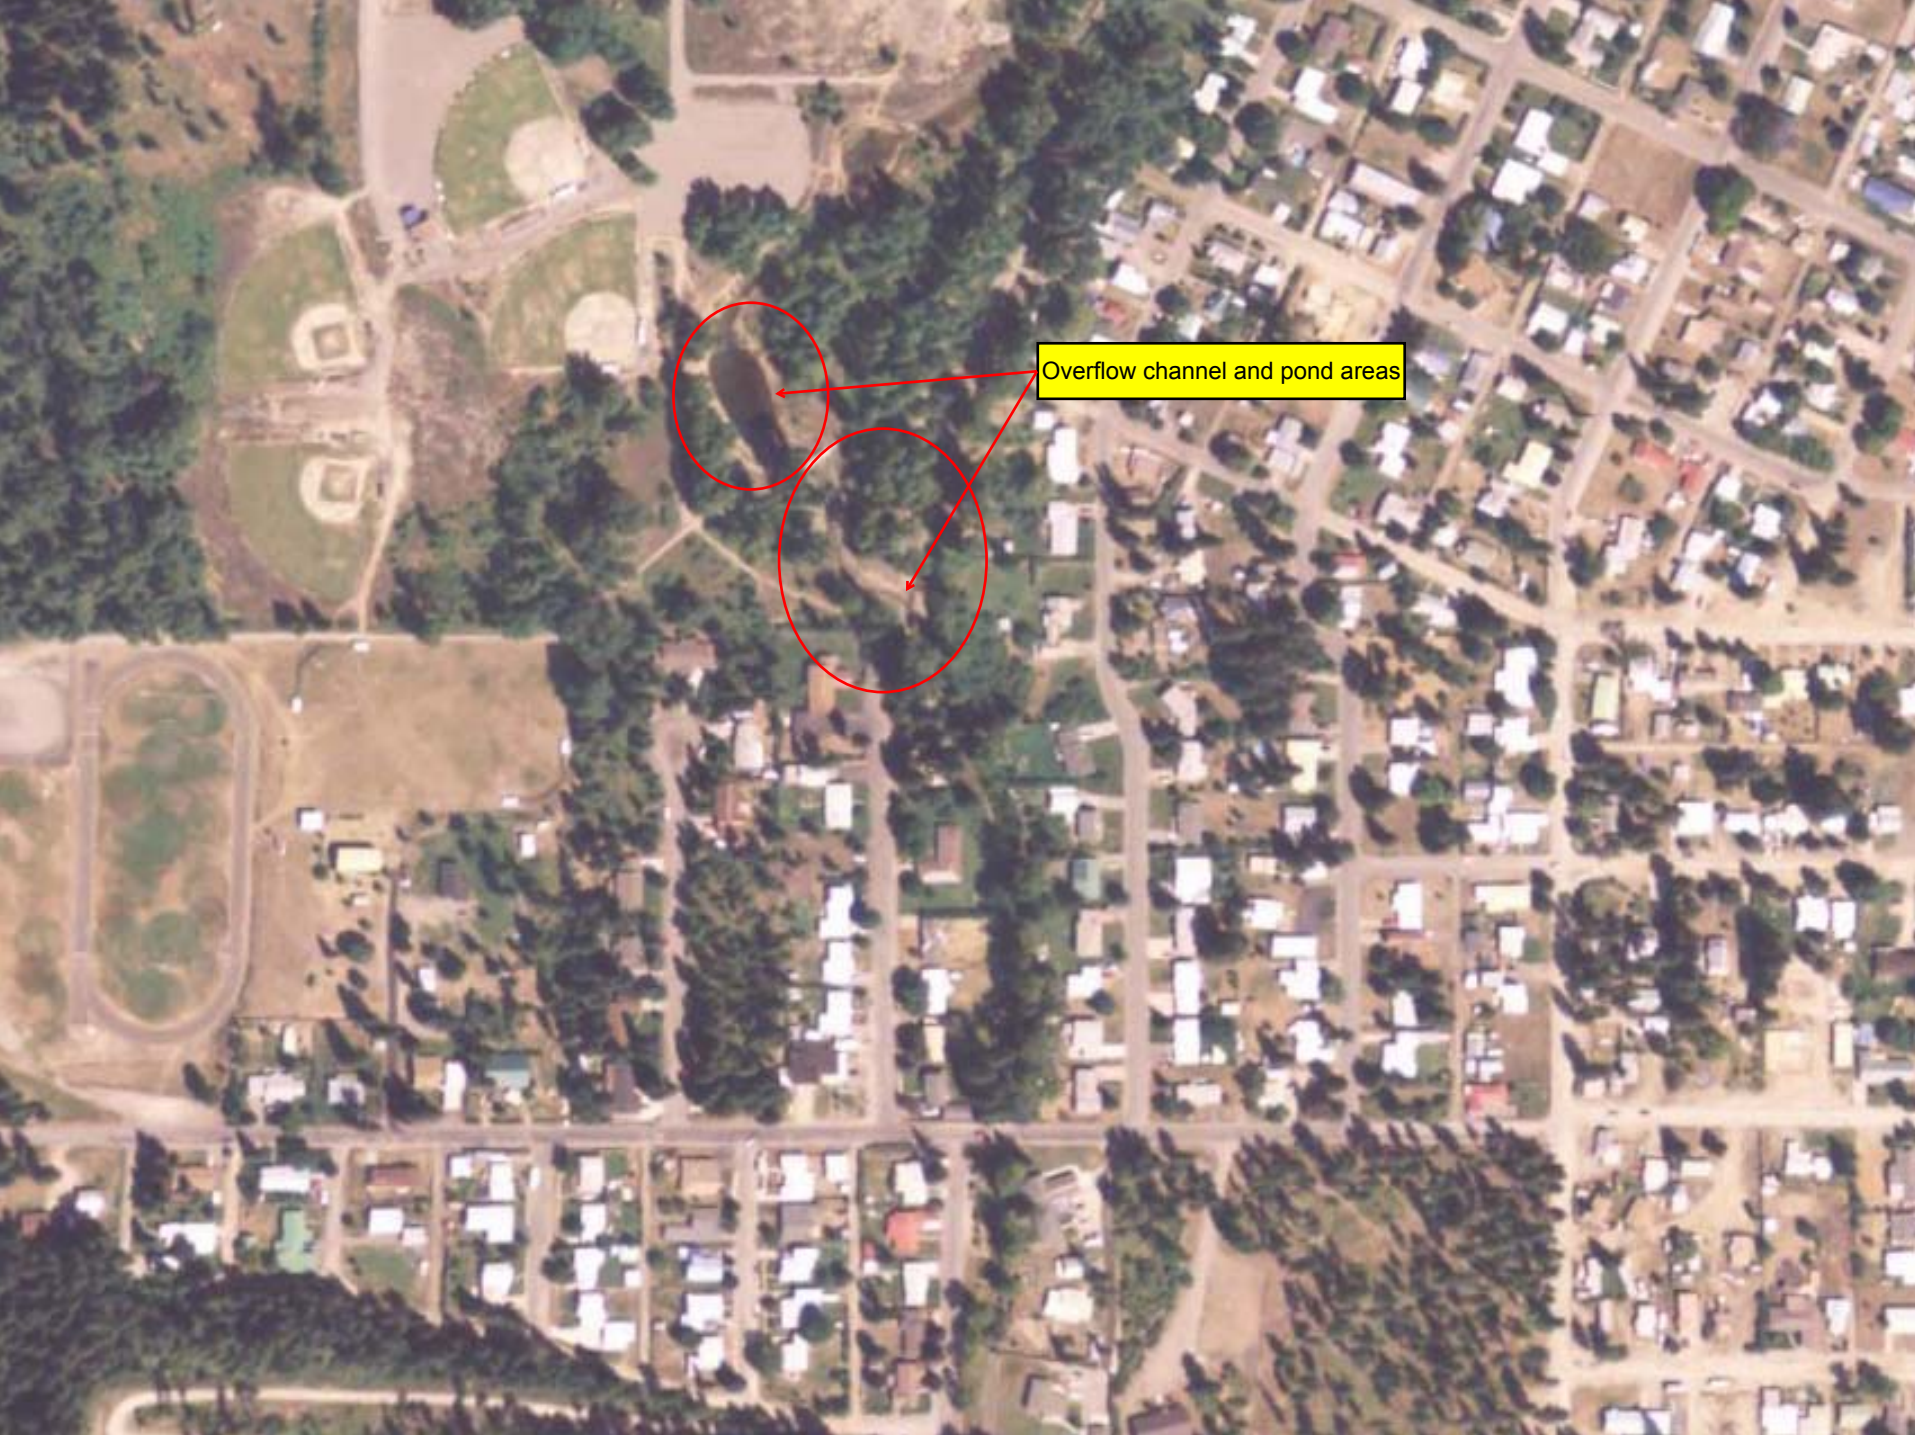
A visual inspection for suspect material was conducted downstream of the West Balsam St bridge to the Kootenai River and no suspect material was observed. However, at least one area was identified as having potential for contamination to be deposited as it is carried downstream. This location is a large overflow pond approximately half way between the upstream and downstream limit of the investigation. At the time of the investigation, this overflow pond was primarily dry, but contained a large amount of small deposited rock.

Overflow channel and pond areas
